# Manhole Inspection Summary

Manhole # S27M\_\_008MH

Insp Date: **5/8/08 10:51 AM**

**Location** Address: **850 Carroll St**

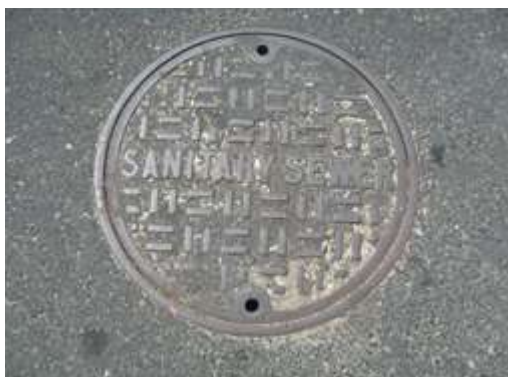
Cover View

MH cover

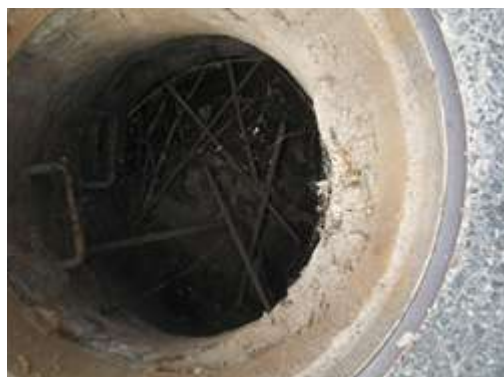
Frame offset 3"

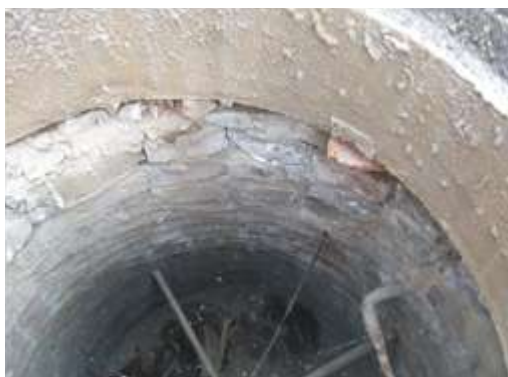
Defect 2

Condition: ☐ Sound ☐ Cracked ☐ Root Intrusion ☒ **Loose Brick** ☒ **Deteriorated**

Infiltration: ☐ None ☐ Joint ☐ Cracks ☐ Mortar ☐ Roots ☒ **Wall**

chimney cond deteriorated, chimney cond  
loose bricks, barrel flow wall

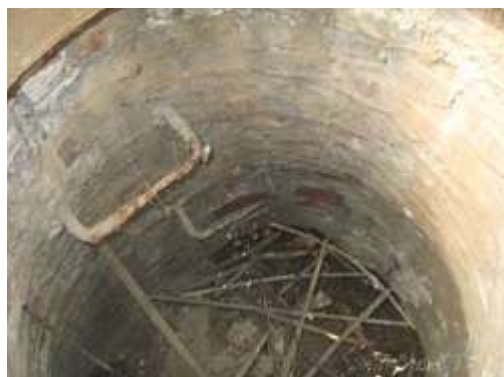
Defect 1

Count: **2** Missing: **0** ☒ **Corroded**

Corroded steps

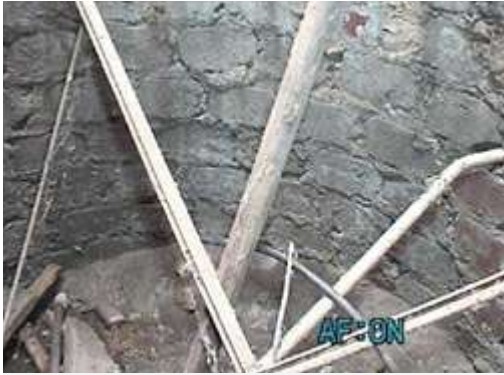
### Defect 3

Condition: ☐ Sound ☐ Cracked ☐ Root Intrusion ☐ Deteriorated ☐ Leaks ☒ **Debris**

channel cond debris

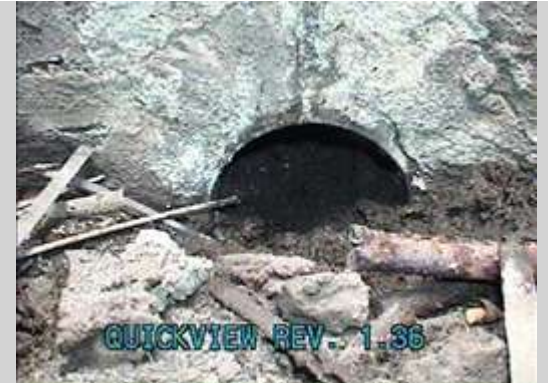
12 O'Clock Outflow

8 in. Circular Gravity Sewer  
Pipe Out @ 12 O'Clock

Deposits: ☐ None ☒ **Mud** ☐ Sludge ☒ **Debris** ☐ Grease

Silt Depth: **6** (in.) Deposits Extent: **Heavy**
